RESTORATION UPDATE

AUGUST 2019

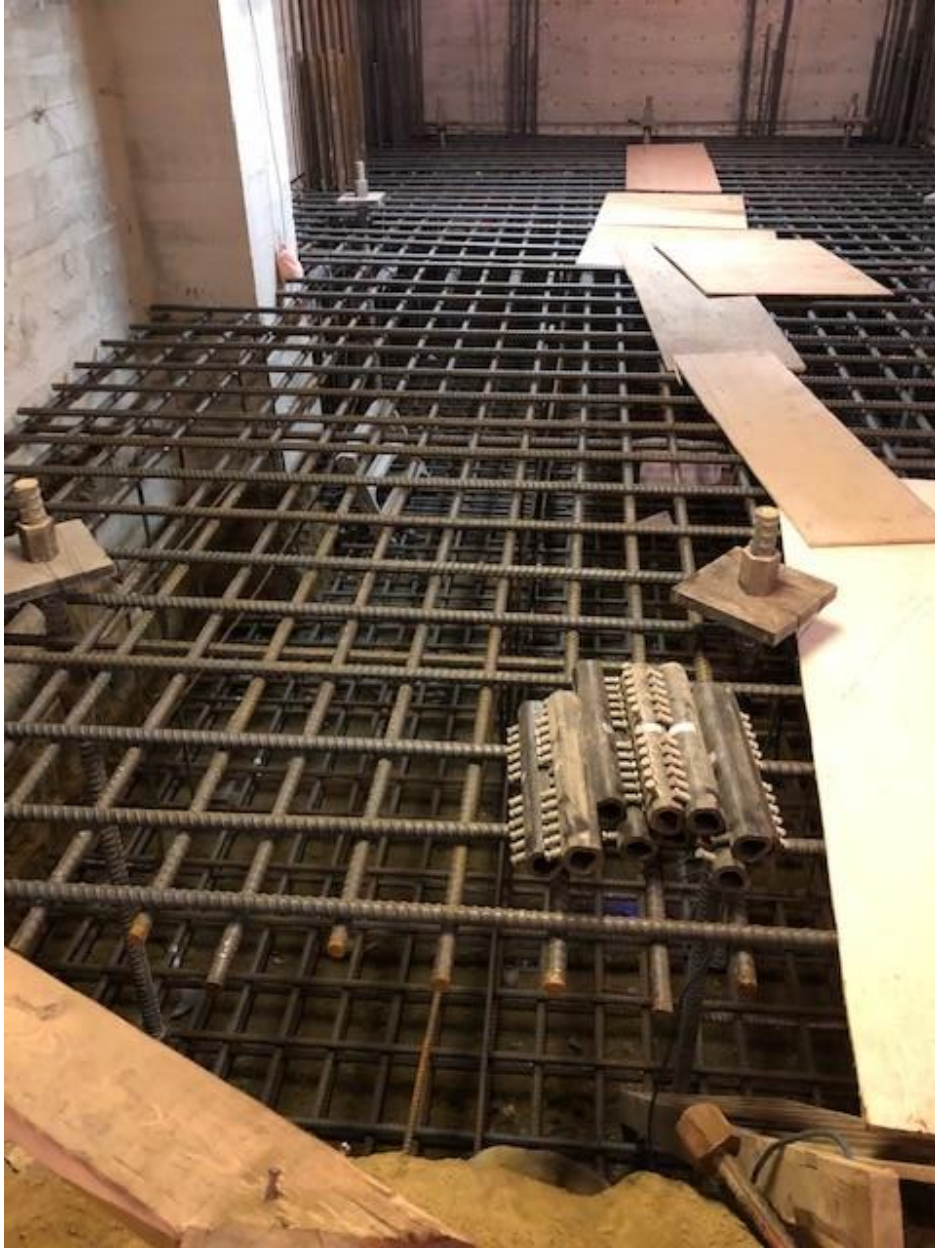
The crypt will have a huge new foundation in it so the shear wall can be built to stabilize the East window wall (wall along Burrard St.). Notice the rebar in the crypt, that is what should have been in all the walls in the church. It will take about 20 truck of concrete to fill the space. The concrete trucks will do a continuous pour which means there will be no time between concrete truck so it is one solid block of concrete.

8 feet of rebar in the crypt

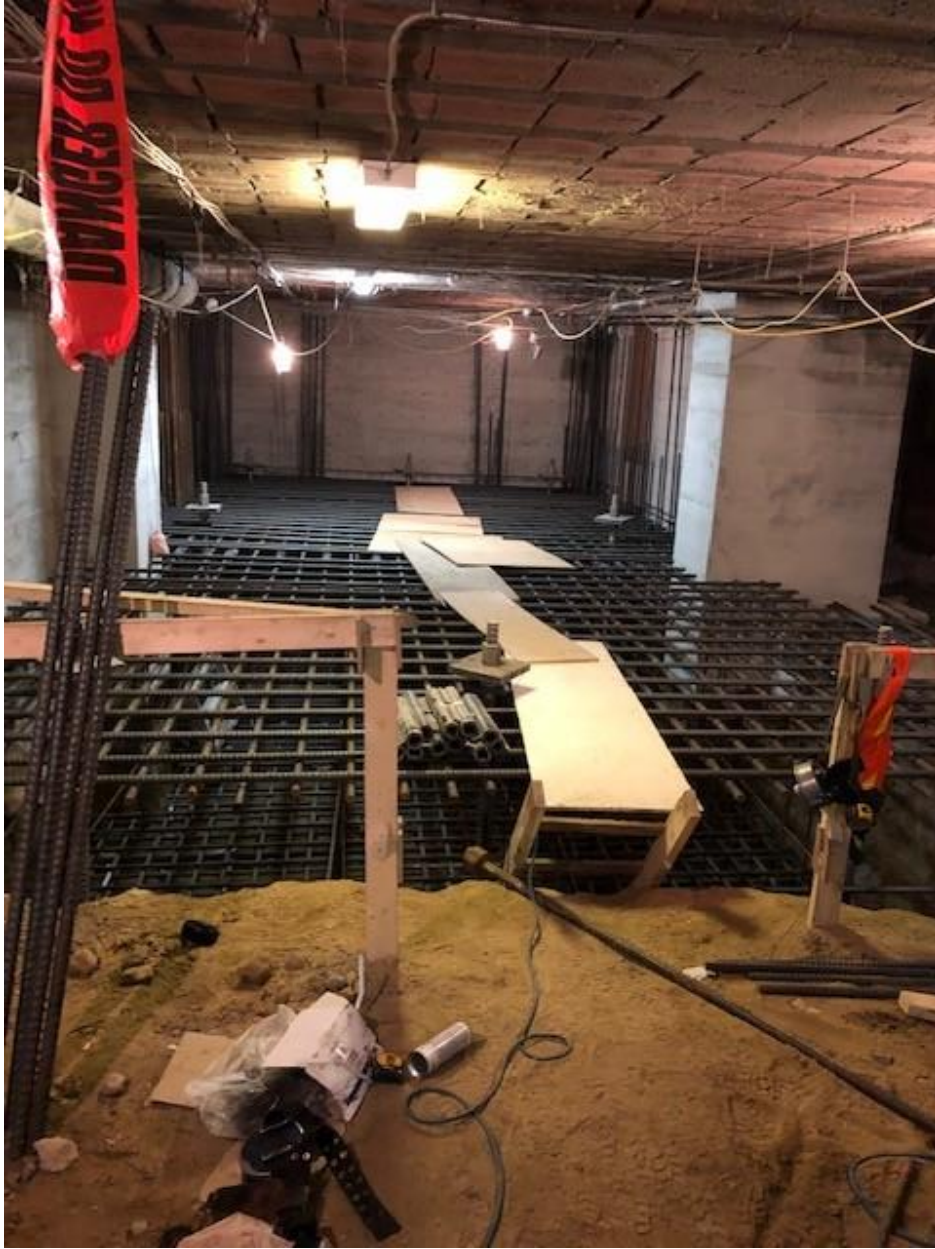
8 feet of rebar for the new foundation in the crypt

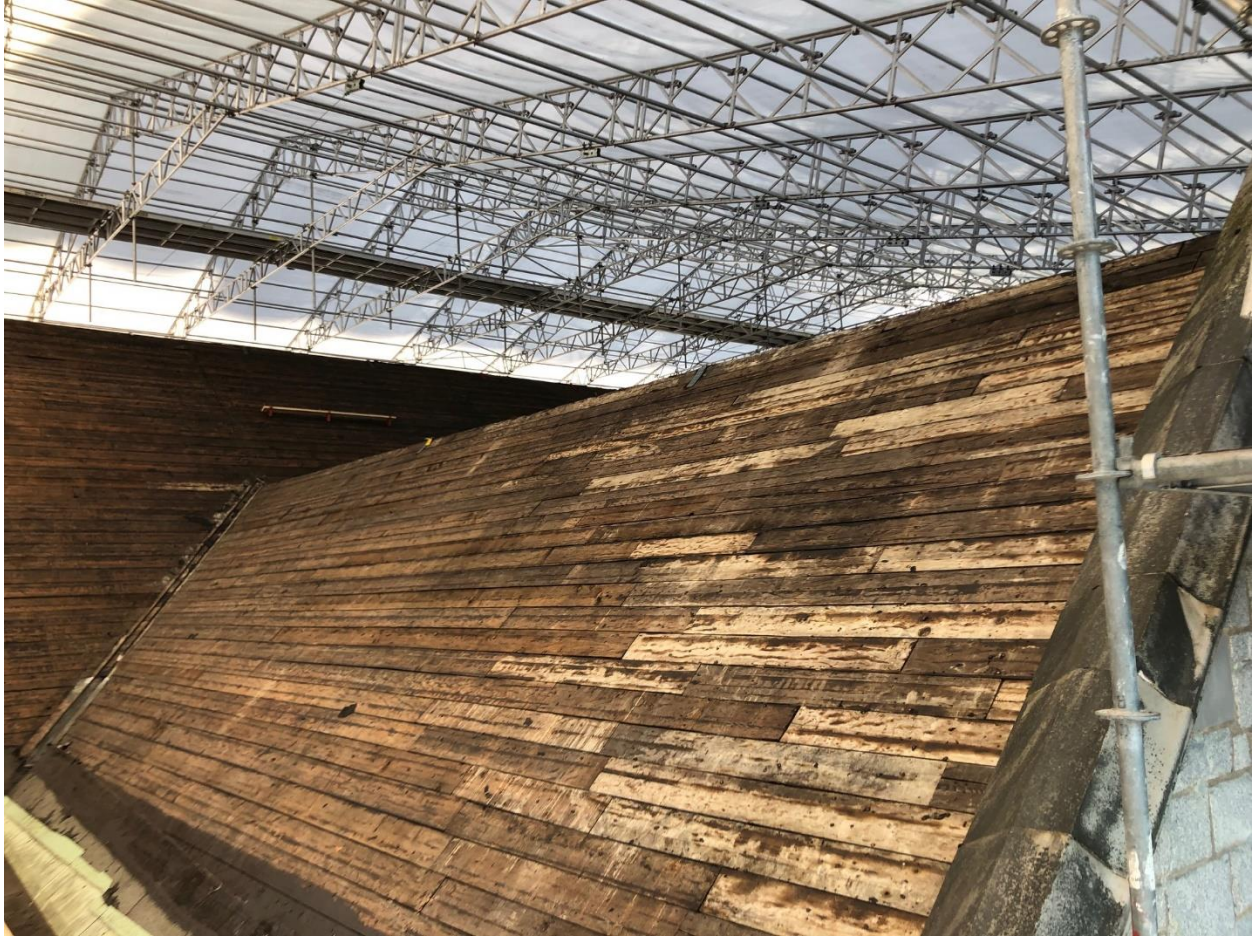
Asphalt roof removed

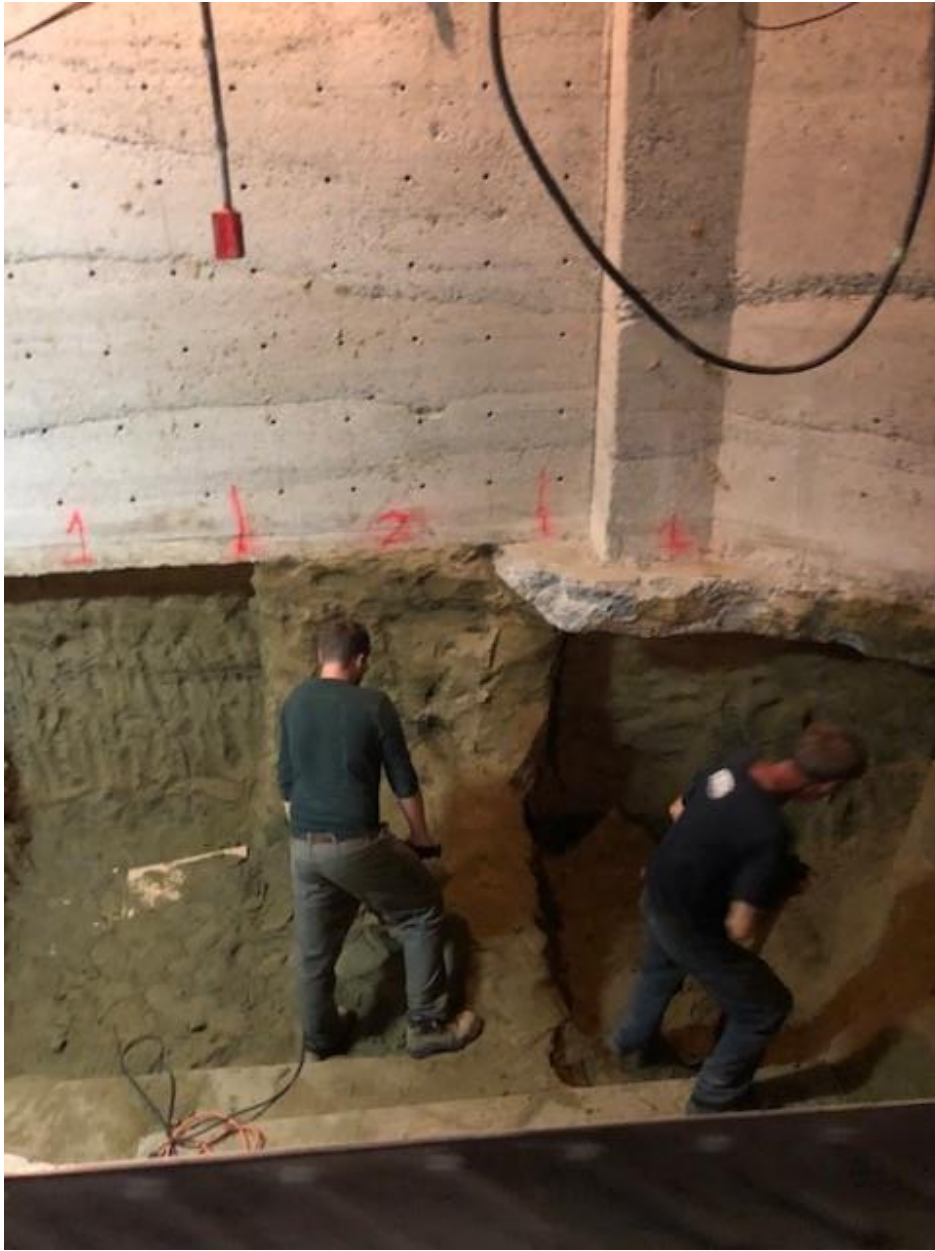
Digging for a new foundation for a shear wall on the sanctuary wall by the Ark room

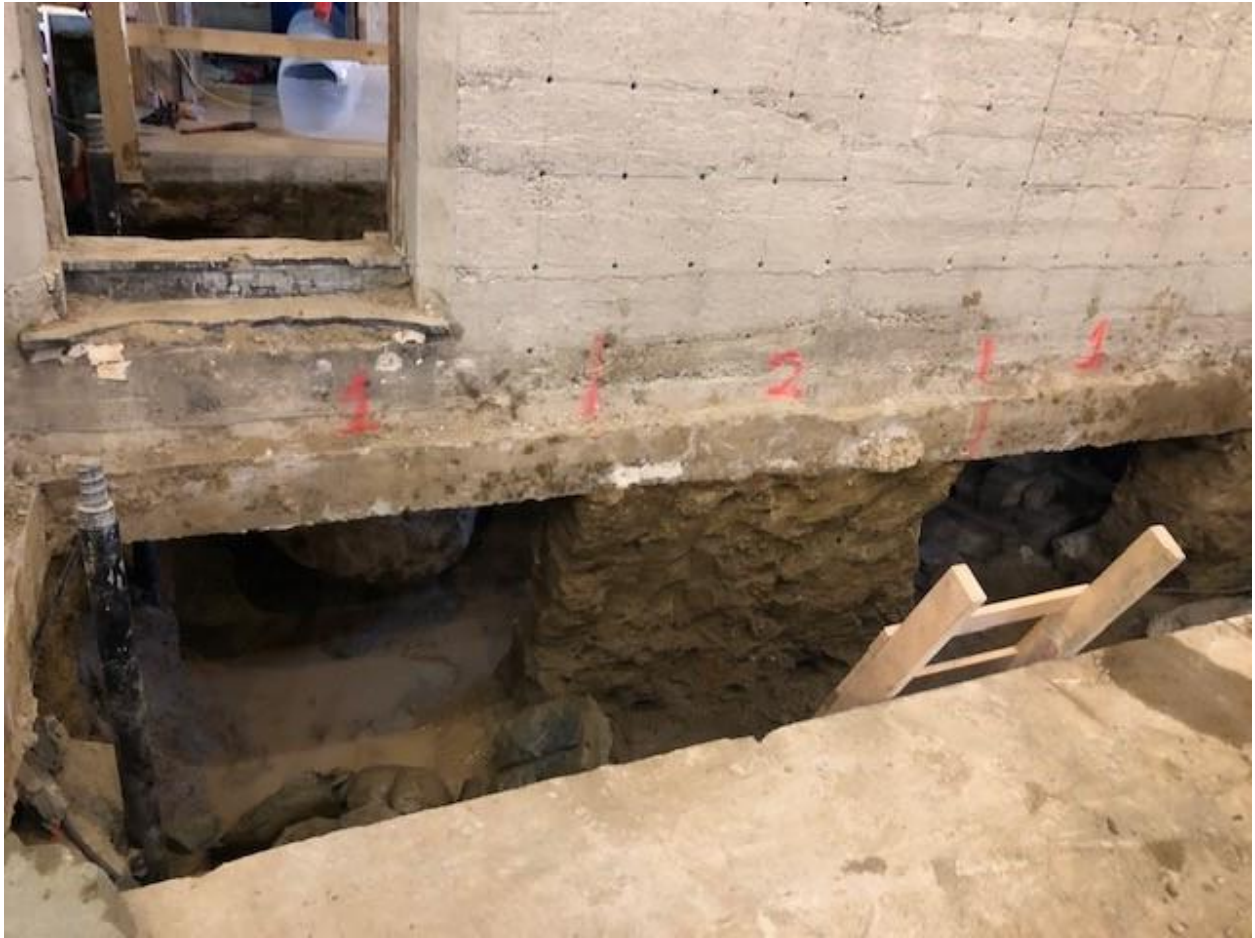
Digging under the Sanctuary wall by Marnie's room for the new foundation

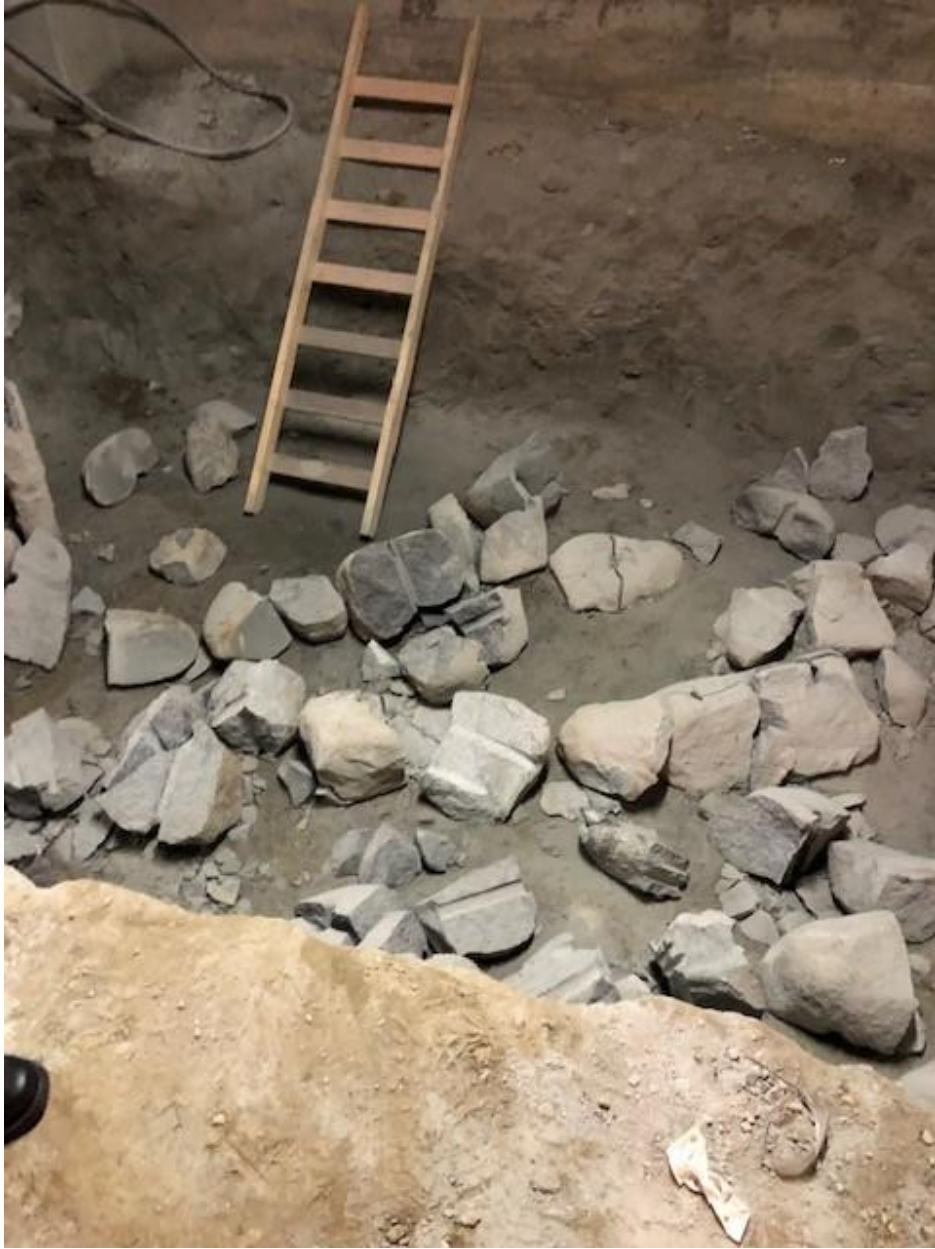
Rocks, we have encountered a lot of them and needed to bring in a rock demolition team to break them up so we can get them out of the holes.

More rocks that have been broken apart by the rock demolition team

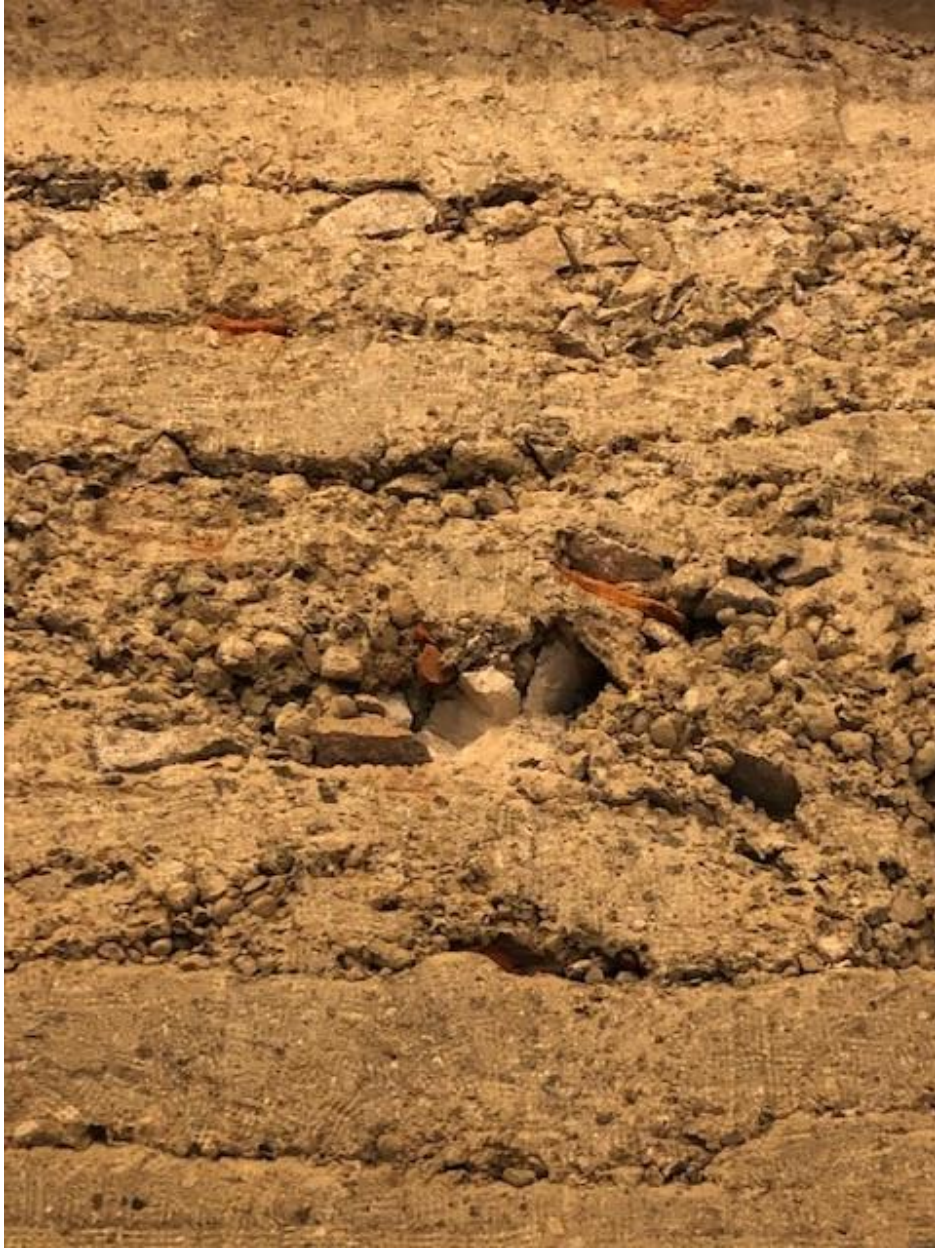
We need to put new foundations and shear walls in because the original walls in the church did not have rebar (steel rods) in them and they were built with poor quality concrete, so they are not as stable as we need them to be. In an earthquake the church as it was built would have crumbled. The new foundations and shear walls will stabilize the church in an earthquake and provide us the time to get out safely.

Original concrete wall with terra cotta

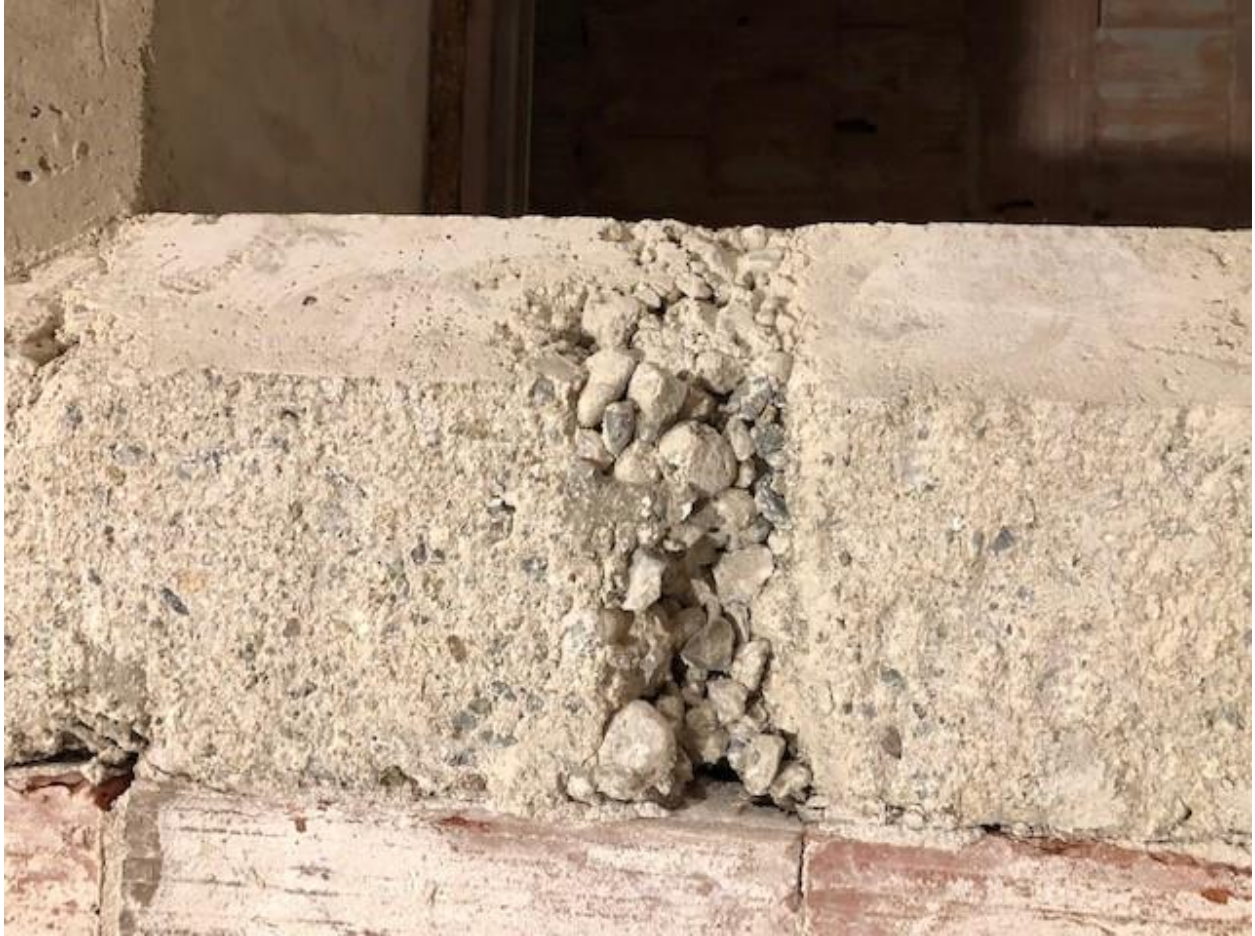
Original concrete wall

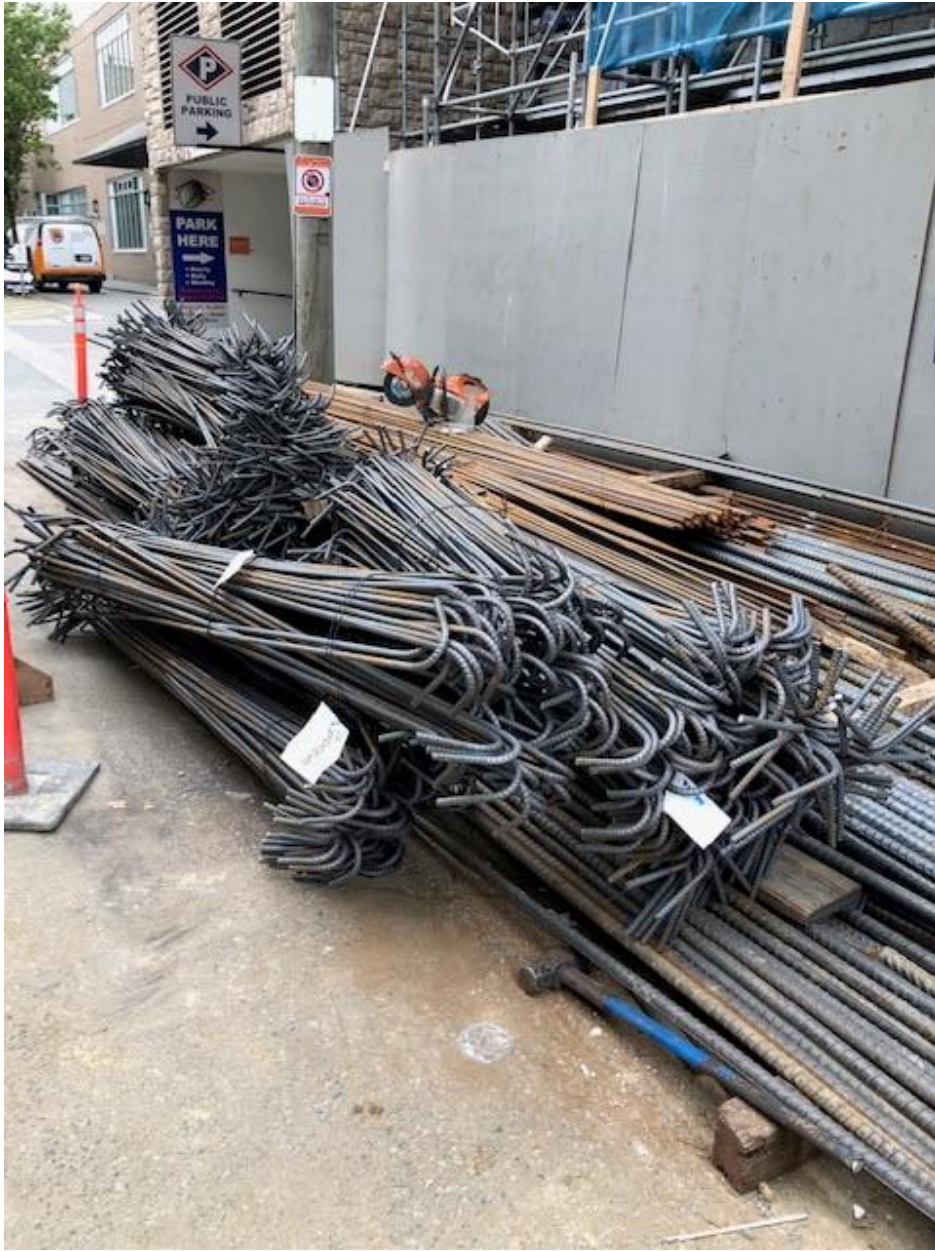
Rebar for the crypt

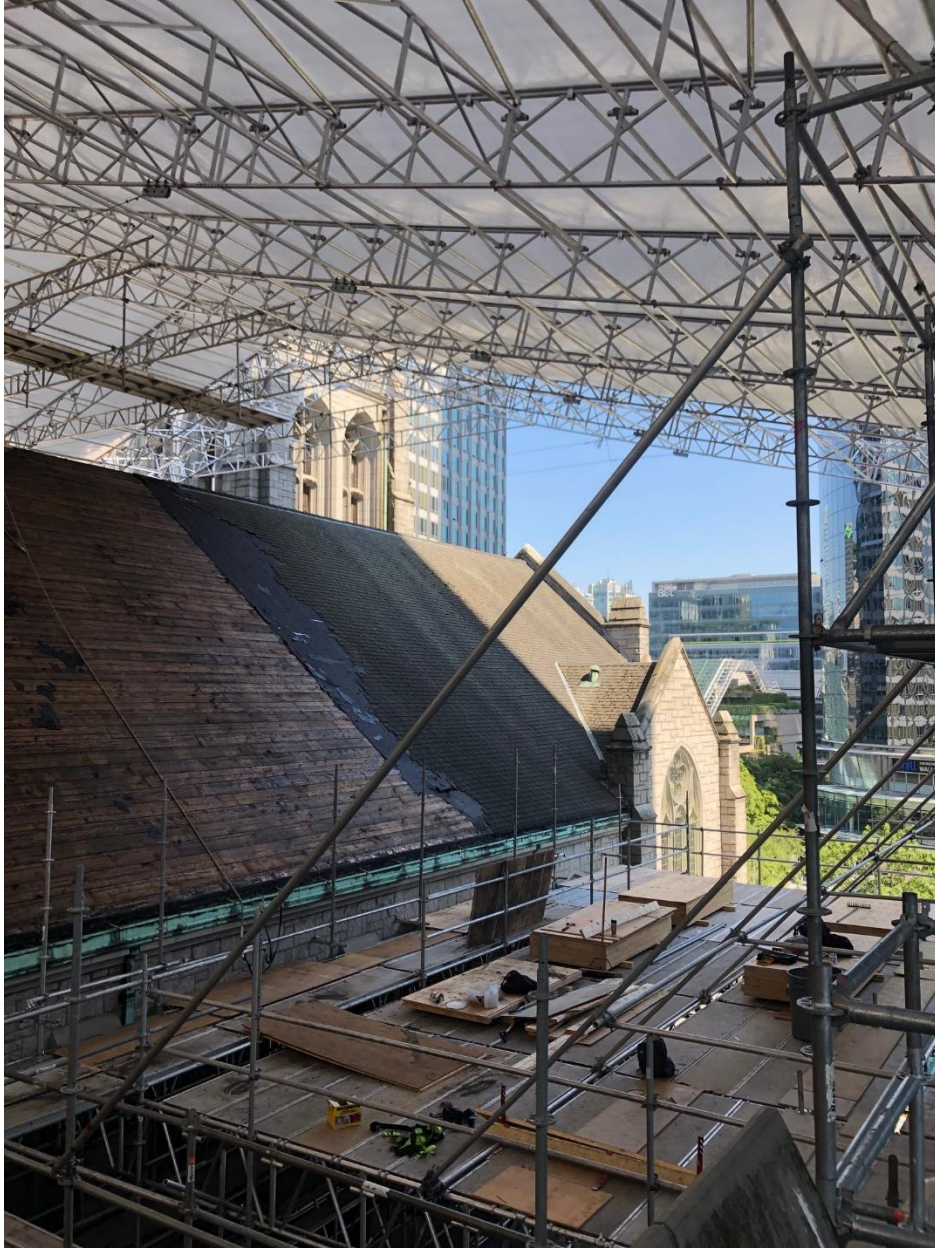
Rest of the roof will be tarped when the scaffolding is completed on the bell tower

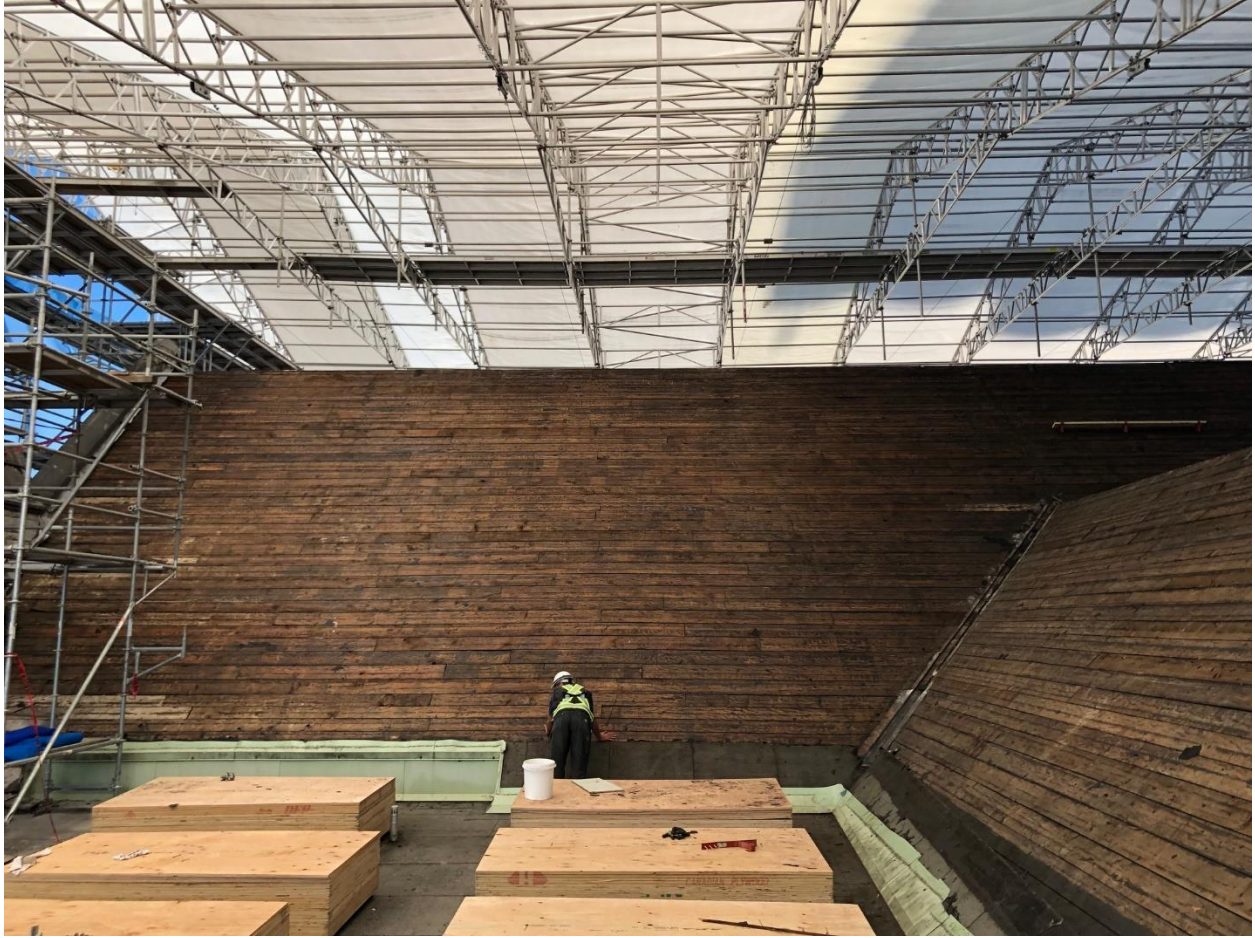
Roof looks mostly in good shape

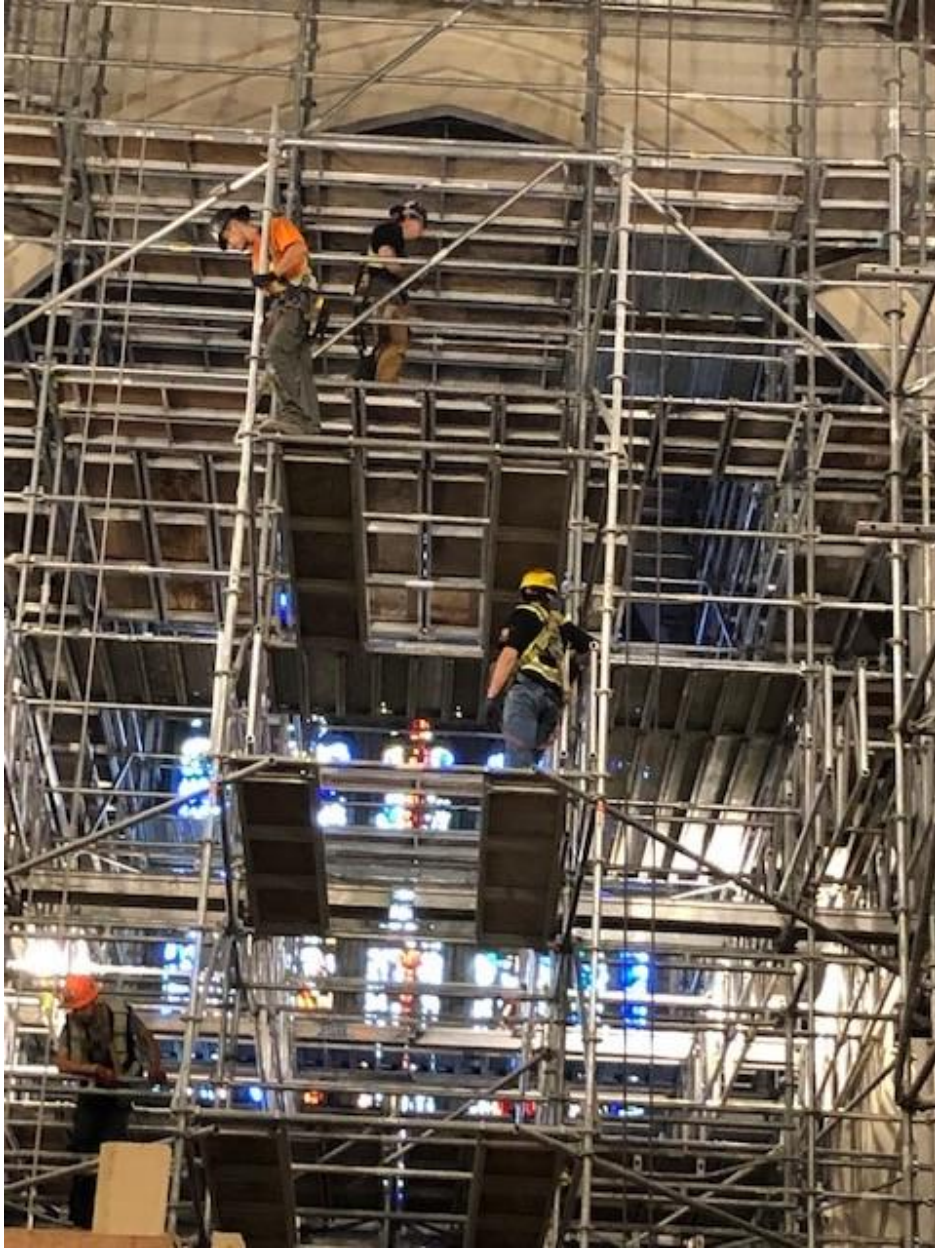
Scaffolding to the roof by the balcony

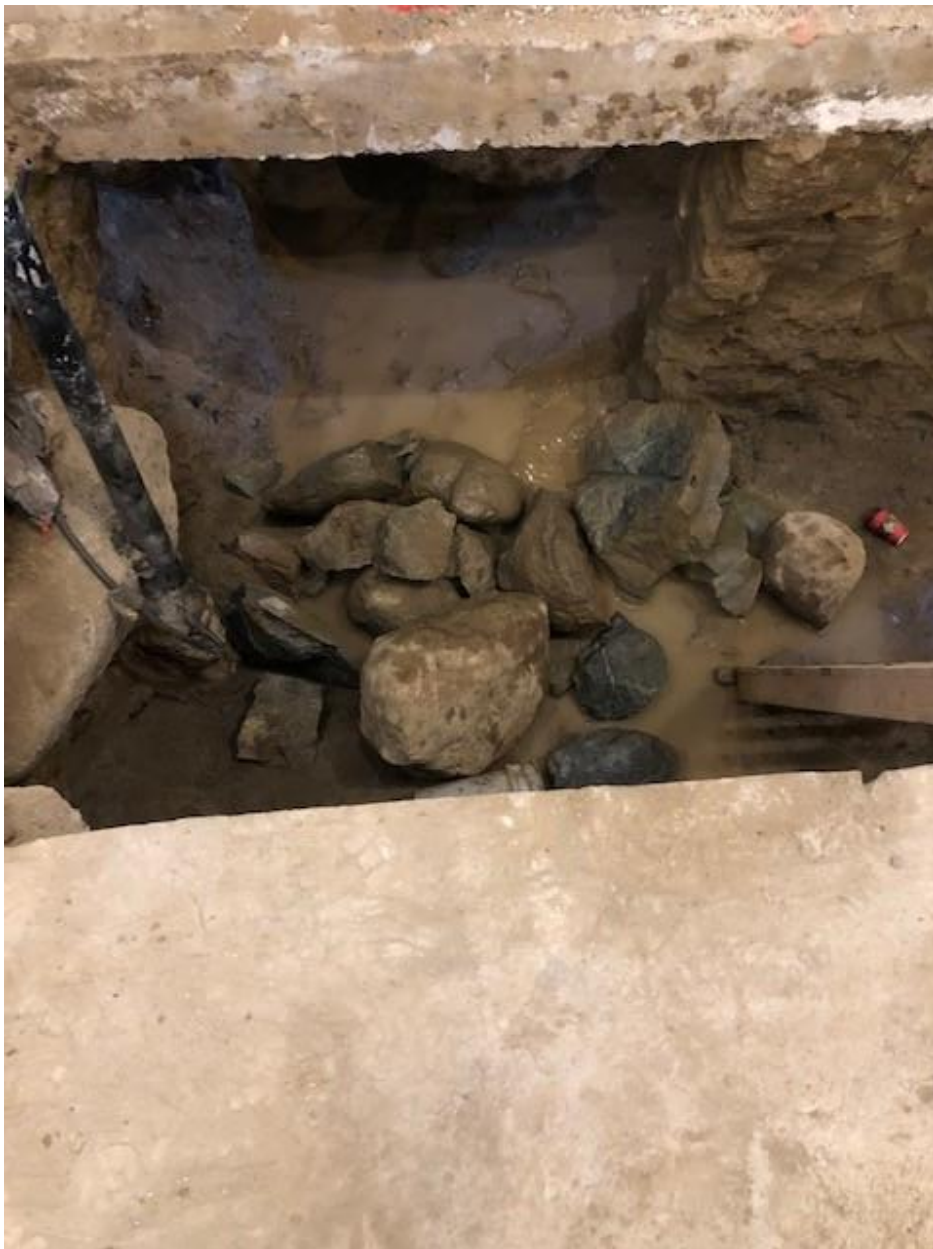
We have encountered lots of rocks in our digging
