I know it has been a while since I last provided pictures but here is the latest.

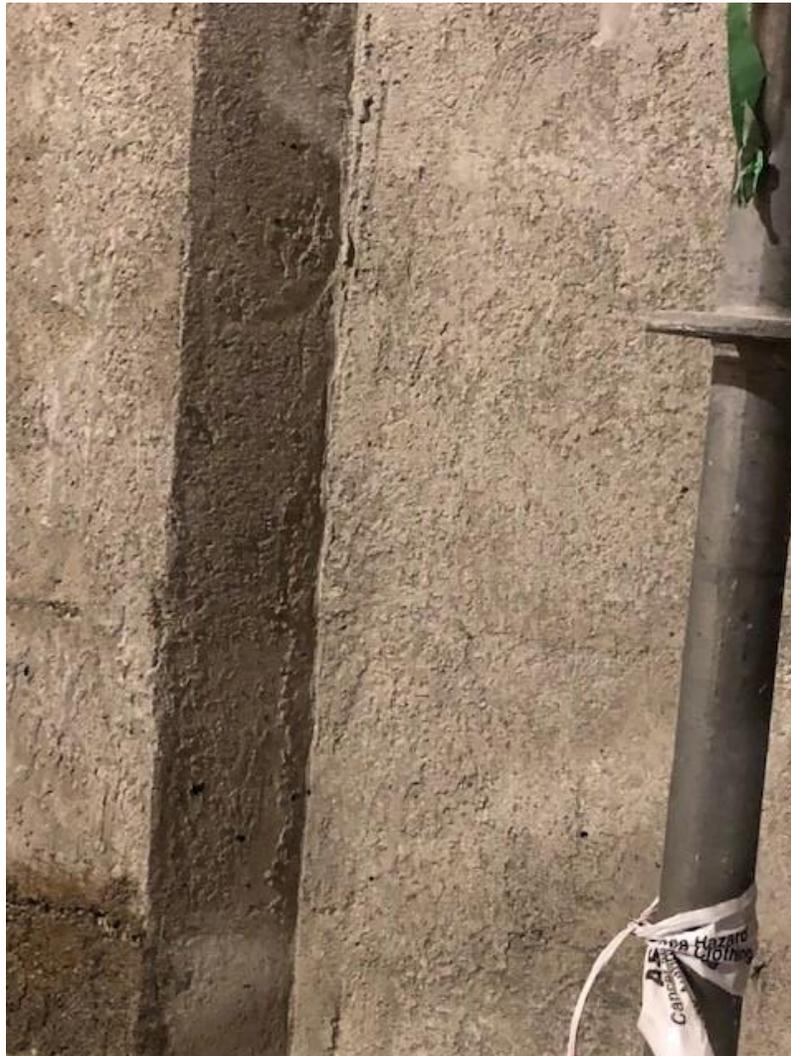
- 1) The concrete on the walls needed to be bush hammered to make it rough so the new plaster will stick to the old concrete. This is done by a tool the guys hold that chips bits of the concrete off the wall. You will have very strong arms after doing that job.

*cement has been bush hammered so plaster will stick*

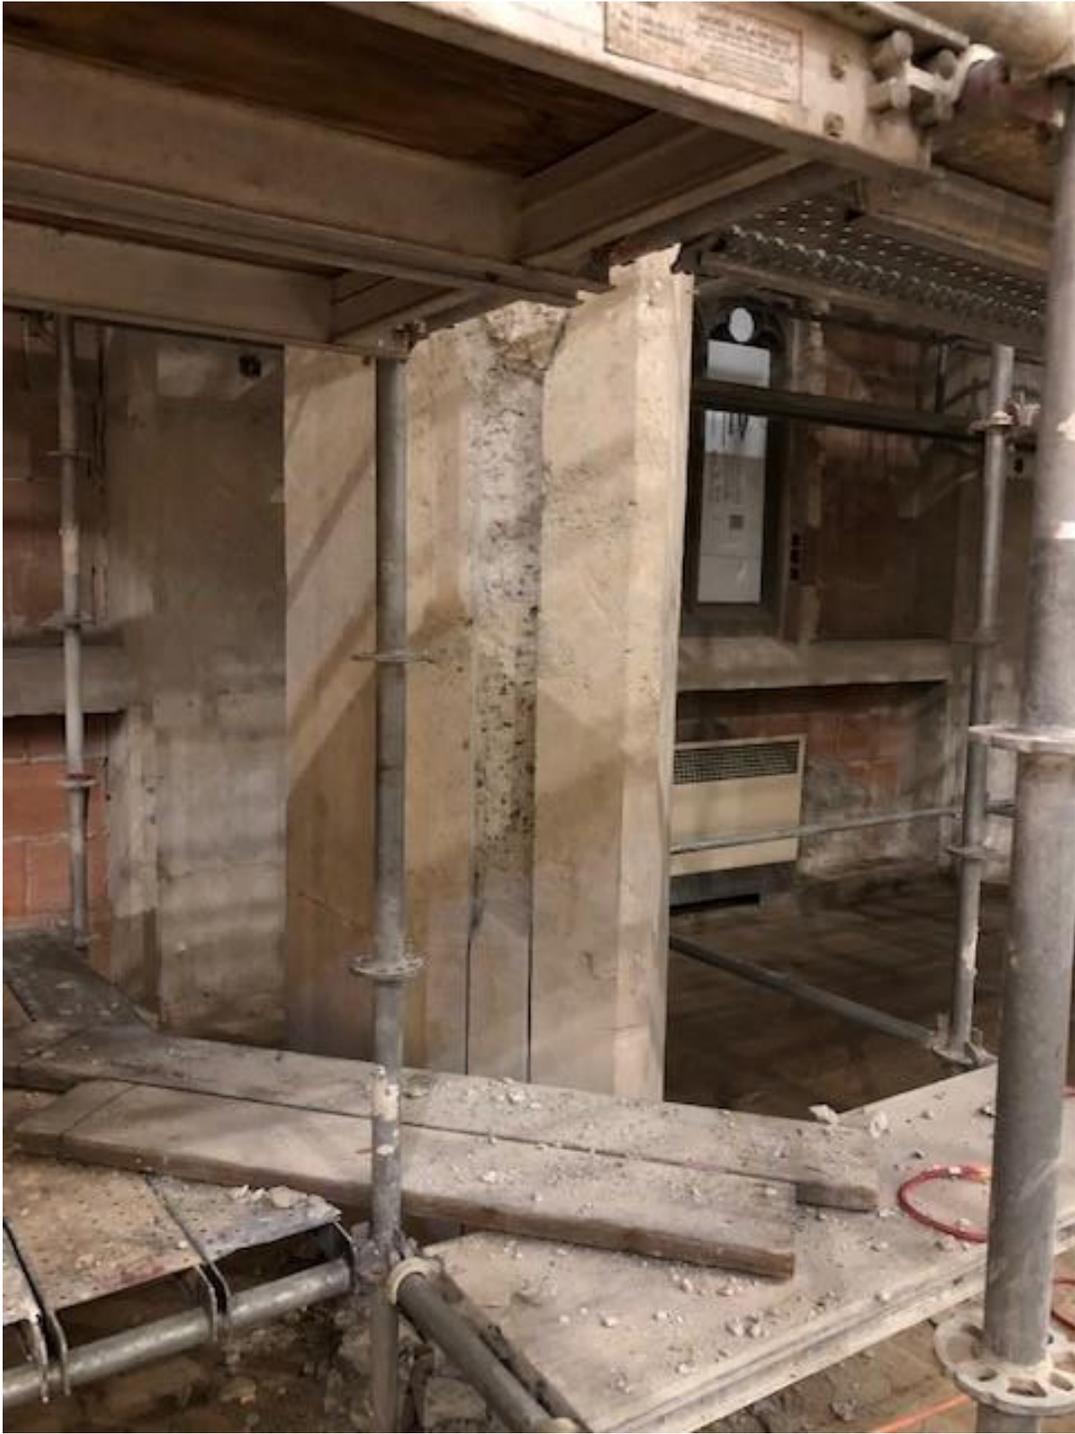
- 2) Channels have been cut into the columns in the sanctuary for the wiring for the tv screens to go into. The channels will then be plastered over
- 3) Does anyone know anything about the 2 cornerstones in the Narthex? Do they have time capsules in them?

*channel cut in columns to accommodate wiring for tv's*

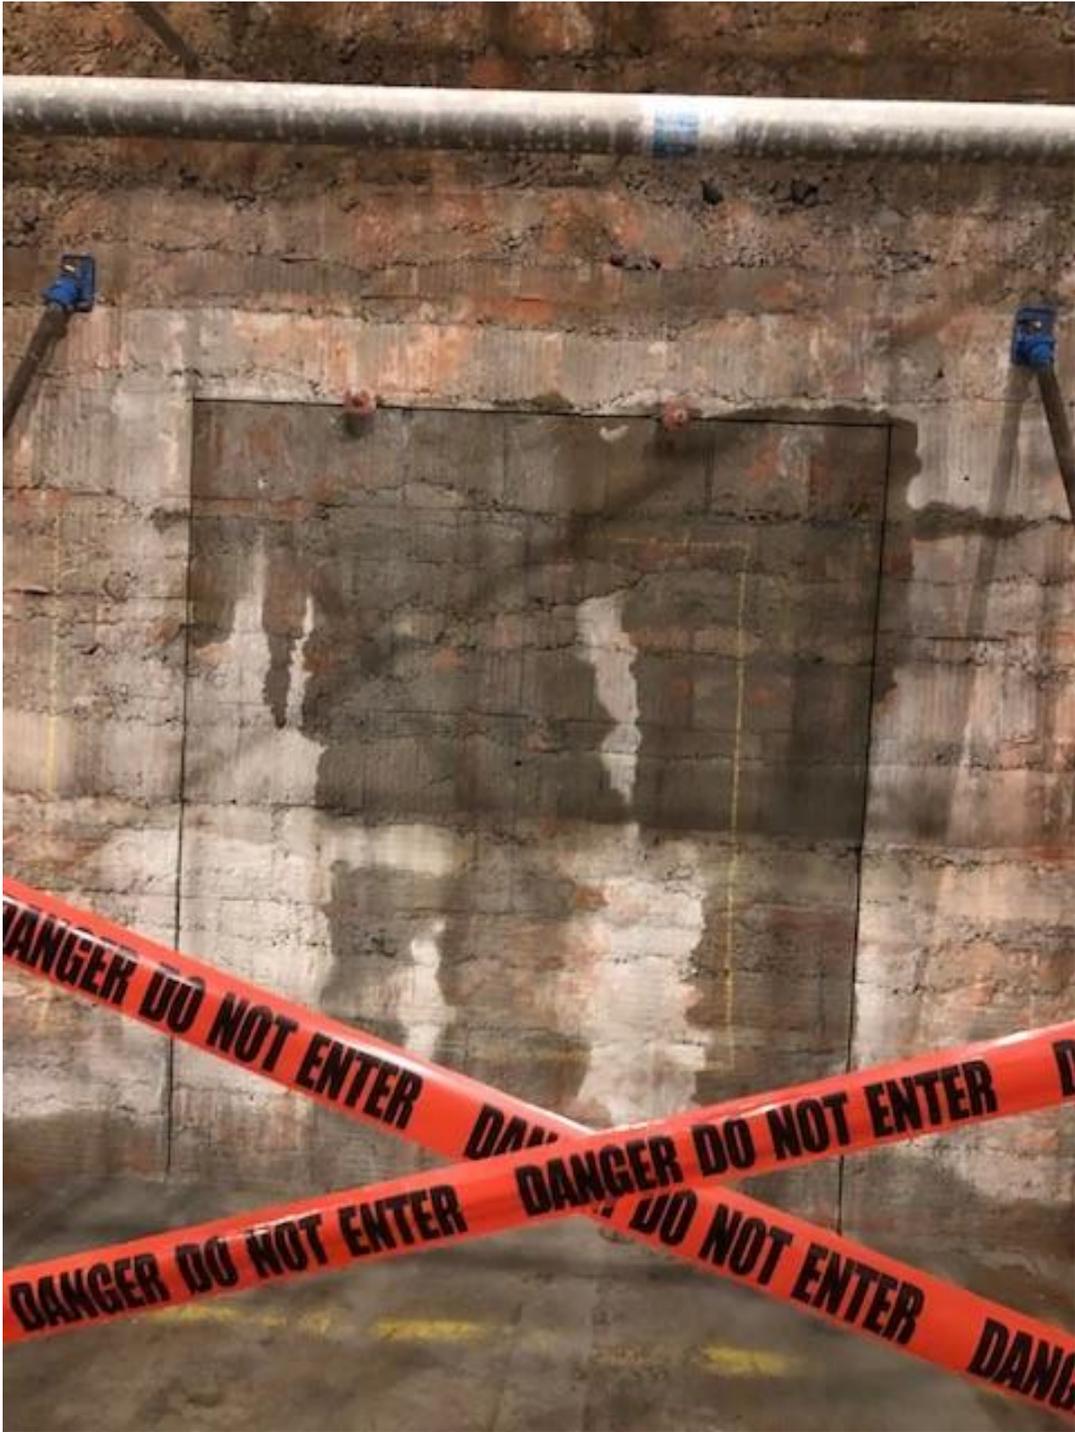
- 4) You can see the cuts in the interior wall to create the new door into the sanctuary from the south transept. The other picture shows the hole opened up from the exterior

*cut to remove part of wall in south transept*

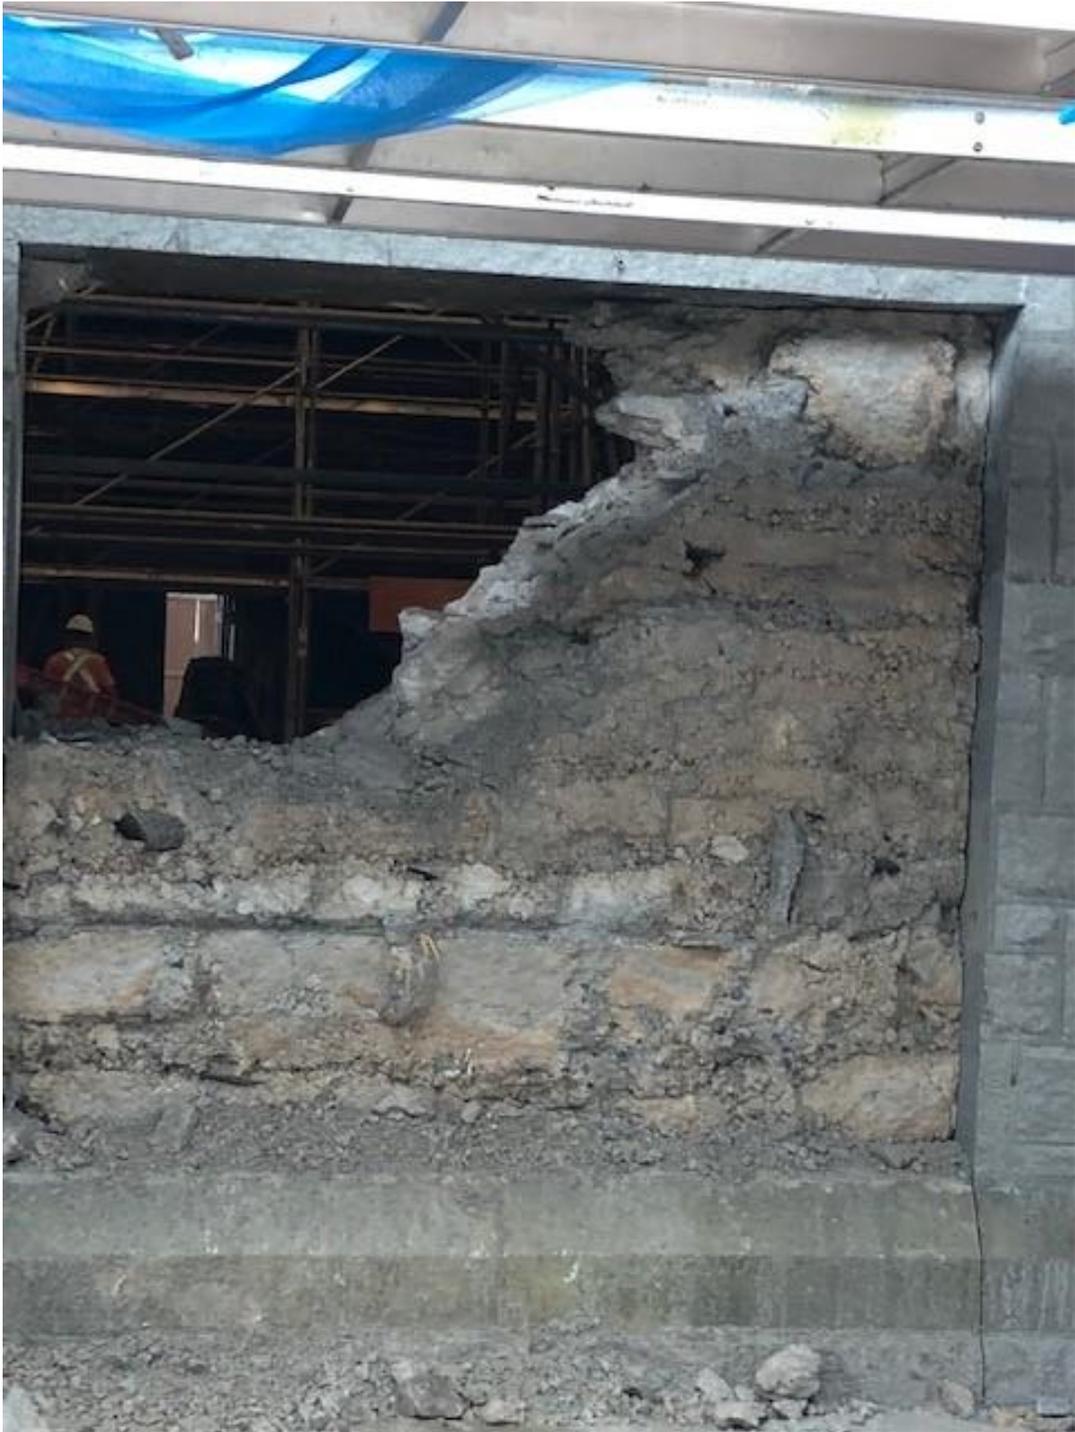
*hole punched through the exterior wall in the south transept*

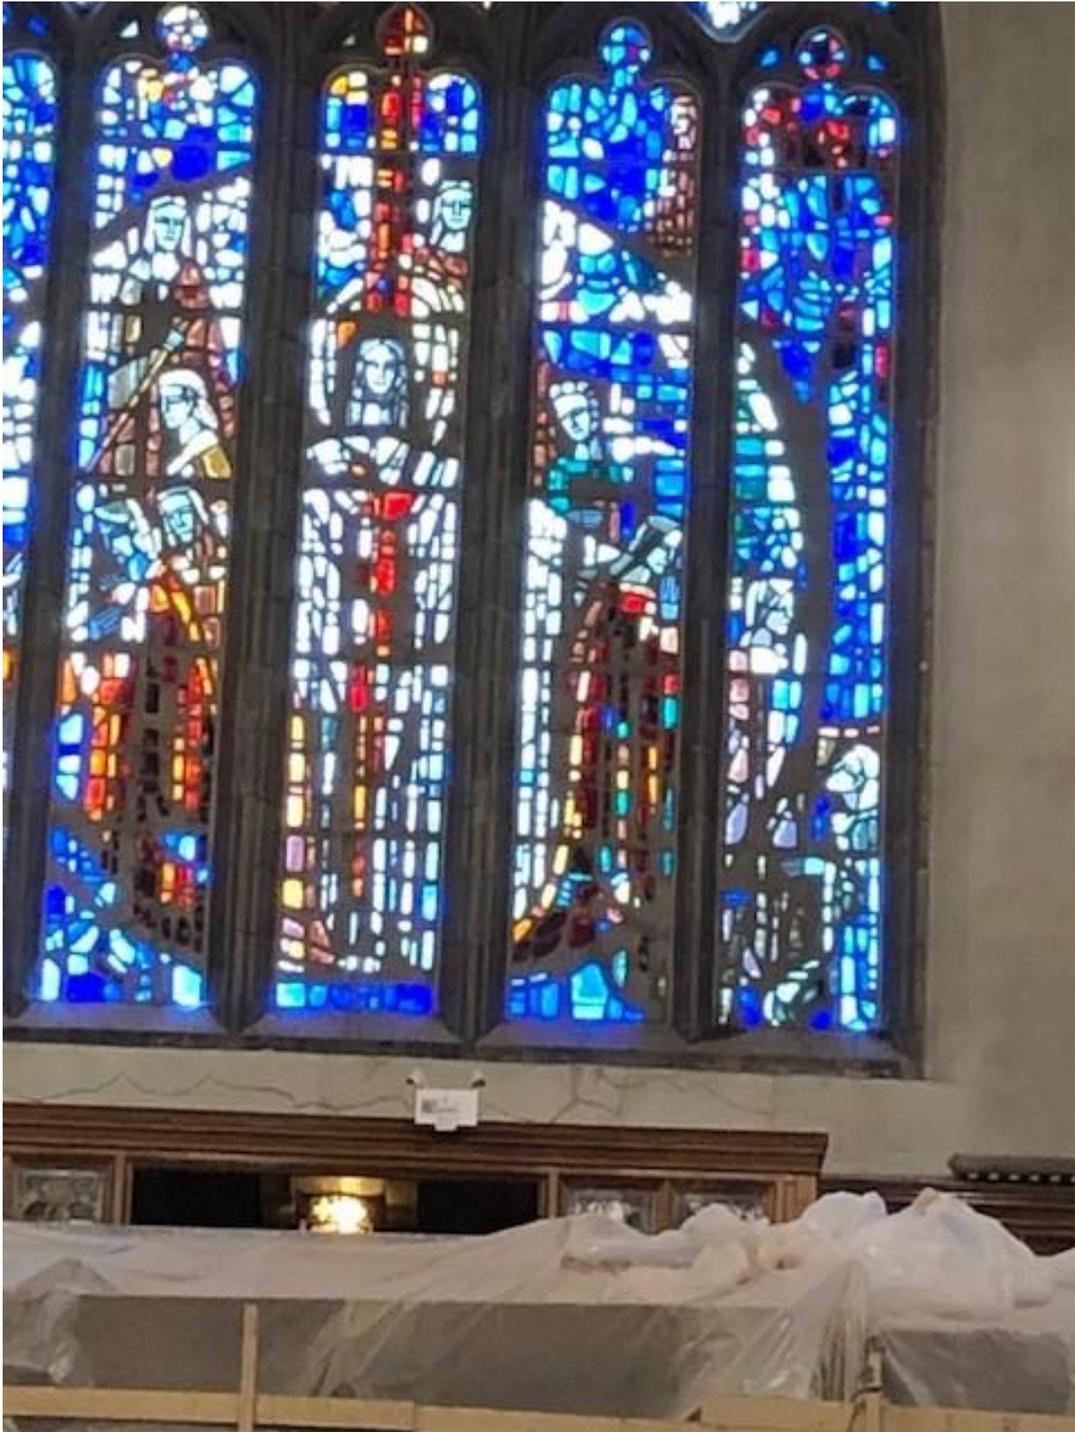
- 5) There are new cracks that have opened up under the East window. No worries we have it all monitored to keep the window safe
- 6) Plaster is being removed from the chancel and the narthex so precautions must be taken to keep the workers safe from breathing in the lead contained in the paint

*new cracks under the east window*

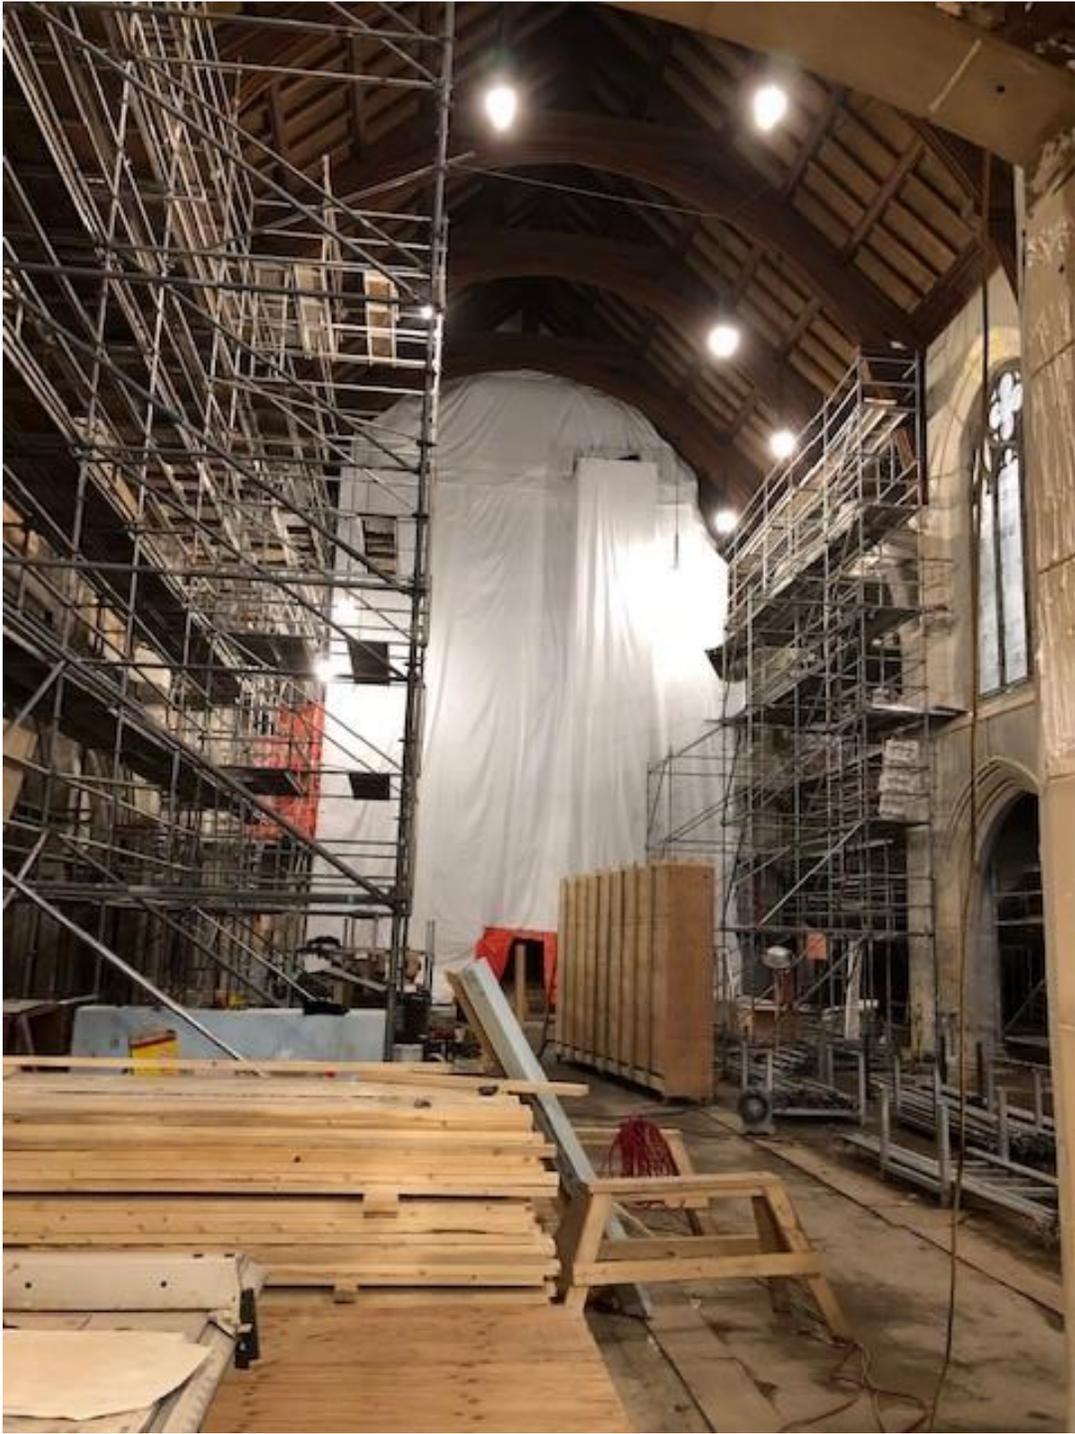
*plaster removal in chancel - lead dust protection*

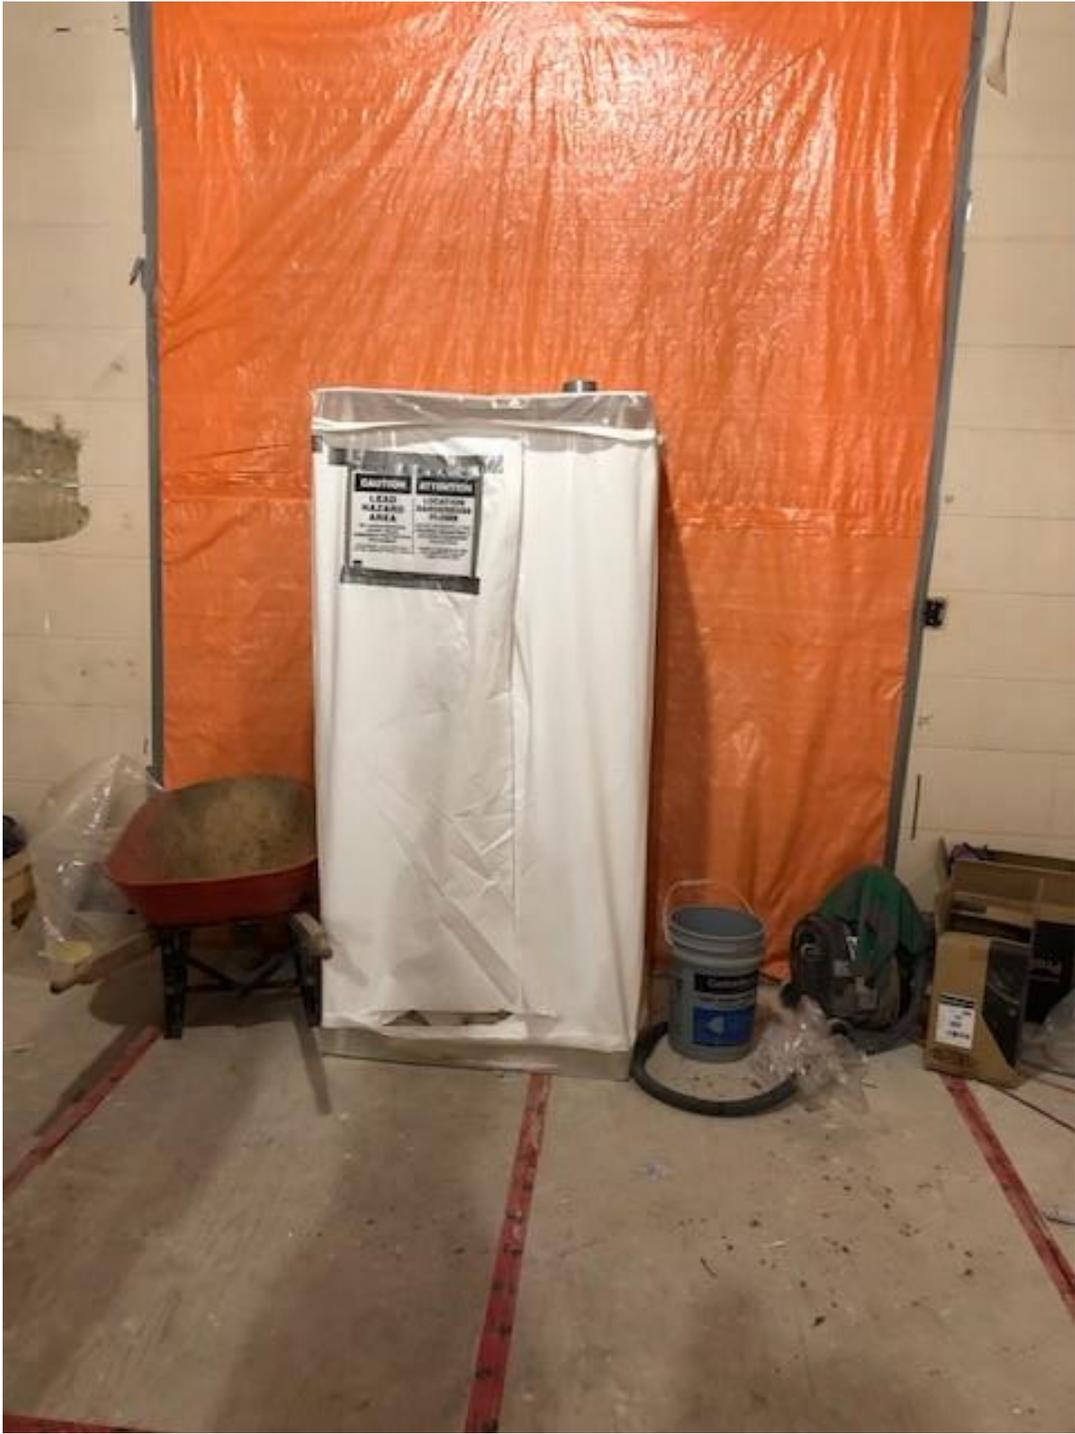
*plaster removal in Narthex*

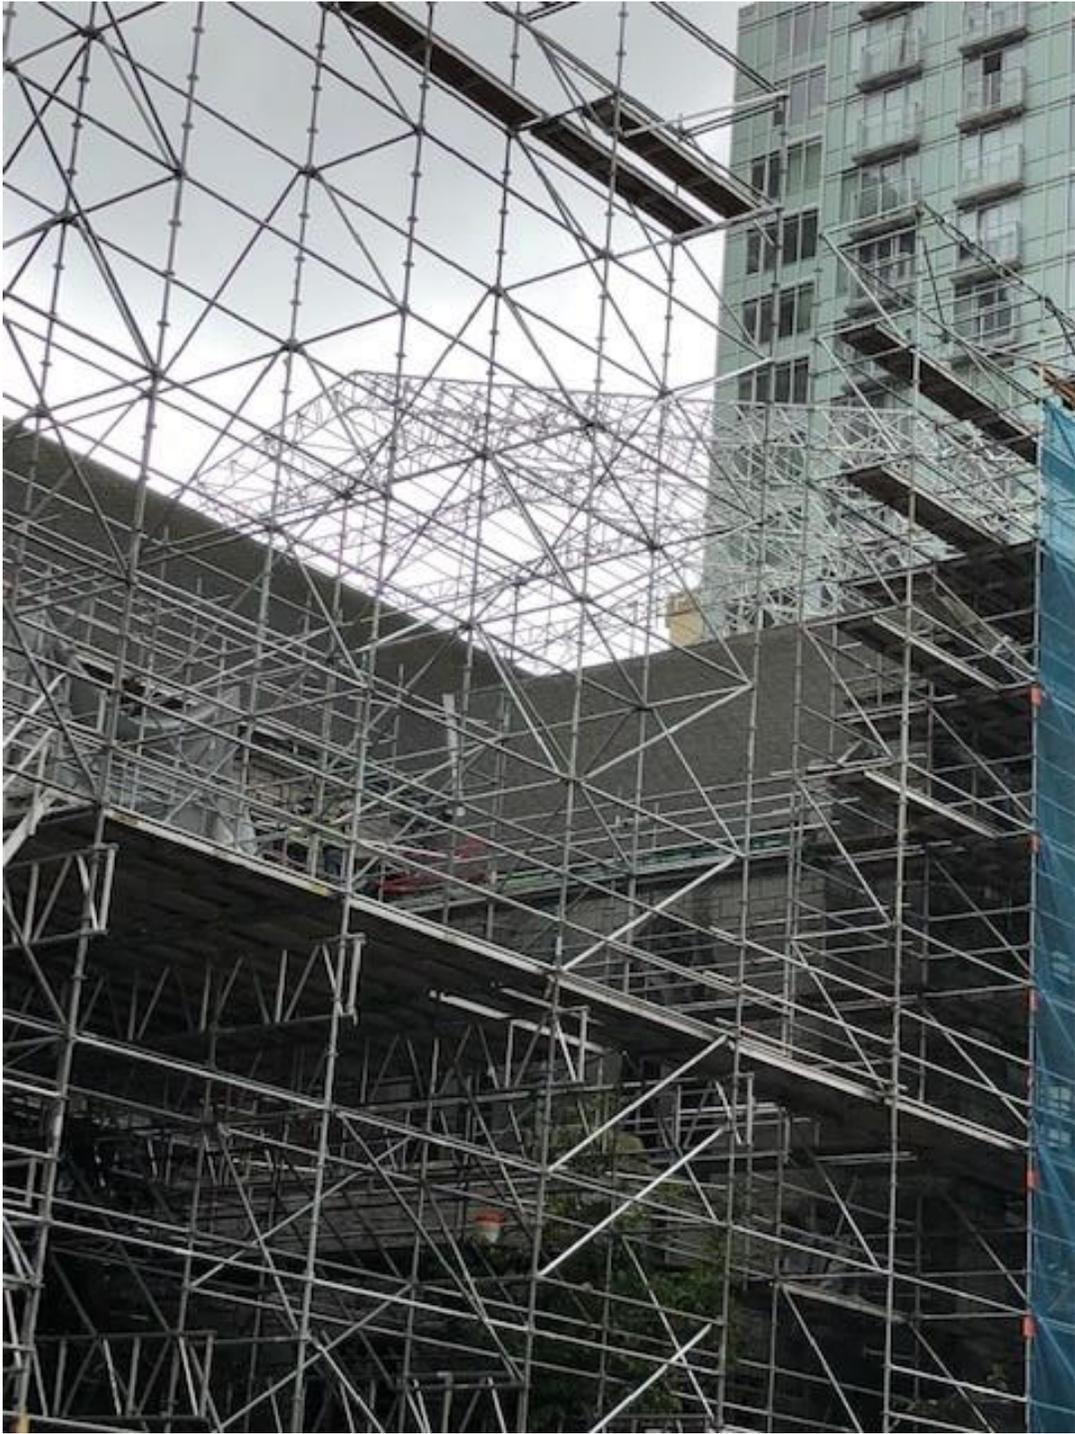
- 7) Outside you can see the scaffolding that forms the trusses for the trap to protect the roof while we work to replace it
- 8) The large arches in the sanctuary were supposed to be built as part of a wall with an arch shape in it. What we found when we opened up the walls were large arches that were holding up that part of the building with rubble used to fill in the parts around the arches. The arches are attached to the roof at the point on the top and on each side of the point. We will now work to secure the arches.

*scaffolding trusses going up so we can cover the roof with a tarp*

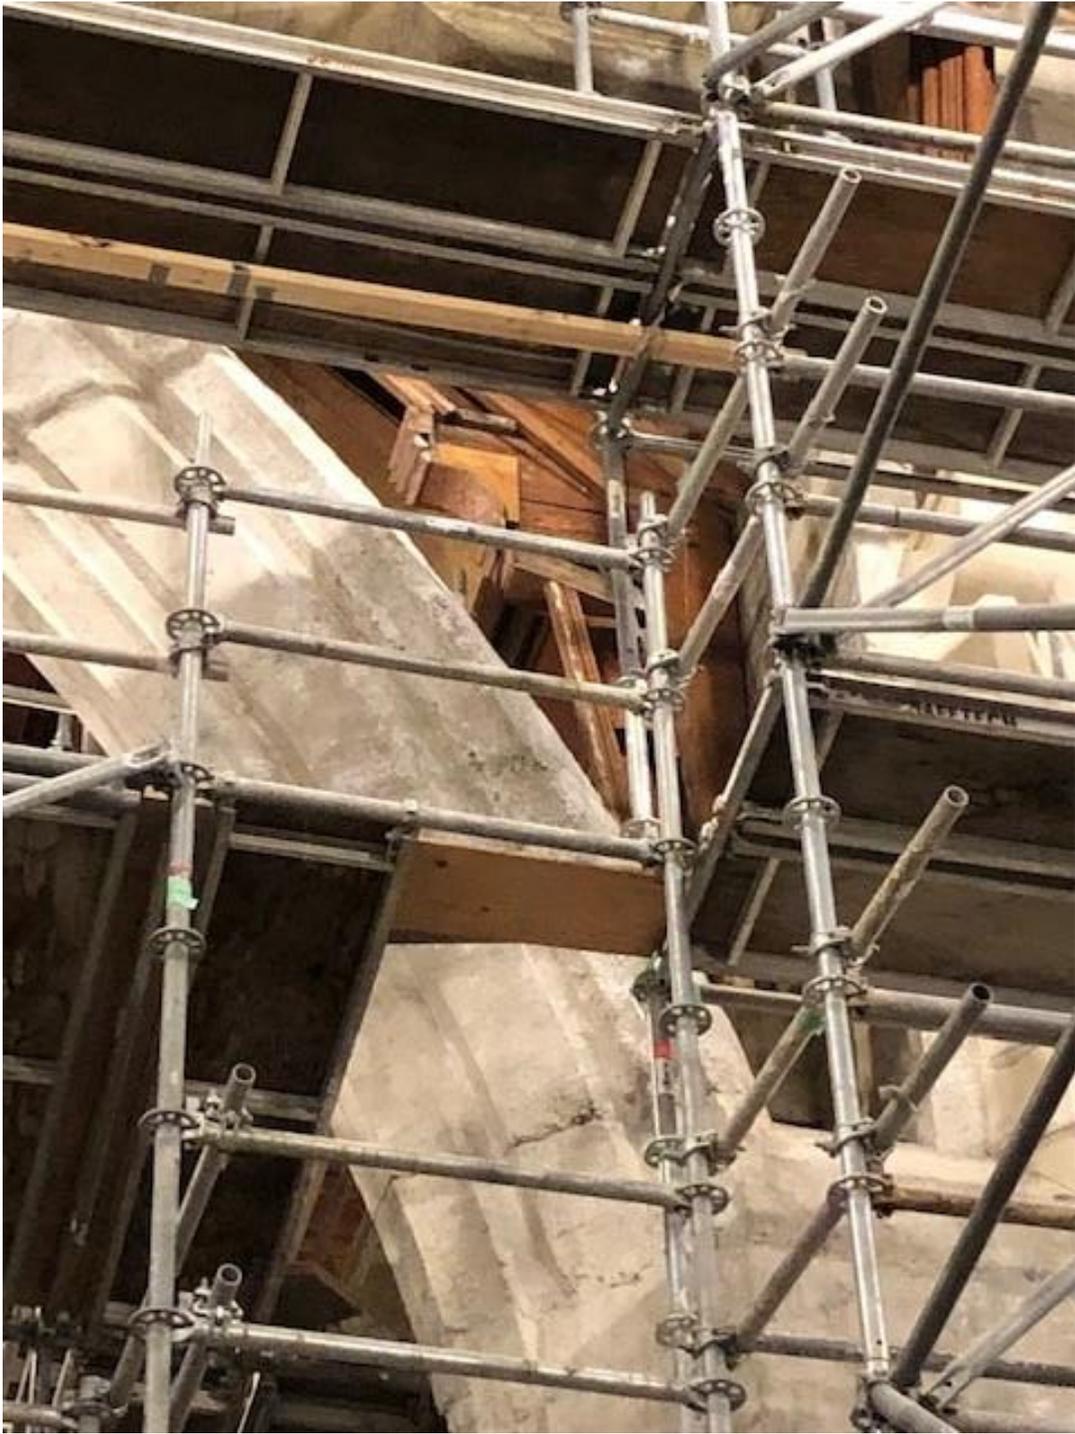
*the arches were supposed to be part of a cement wall, not true*
